ATS AAXICO Technical Services PMA Product Release

D5725143320200ATS Knitted Gasket

INSTALLS ON: A319 Series A320 Series A321 Series

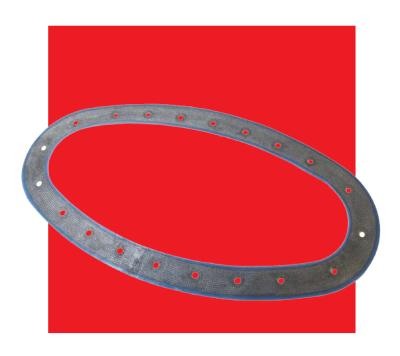
The KNITTED GASKET is part of the aircraft underwing door panel installation and is essentially a seal for the inspection hole covers. The inspection hole covers are located on the bottom skin panels of the wing and allow maintenance personnel access to the wing structure.

The KNITTED GASKET is made of a knitted aluminum wire mesh with a fluorocarbon rubber edge seal. It features a hole pattern along the mesh that is reinforced with grommets made of the same aluminum wire mesh. The KNITTED GASKET is impregnated with general purpose airframe grease to protect the part from degradation. The part measures approximately 470 X 246 mm.
